Notice Number: DF 1401

“SAFETY DIRECTIVE”

Make and Model of the affected LSA: All Pitman Air Dragonfly, 582 & 912 versions

Description of Correction Action: Change Bolt #8 of Section 9 if Head Marking is “CS” to insure proper performance of bolt.

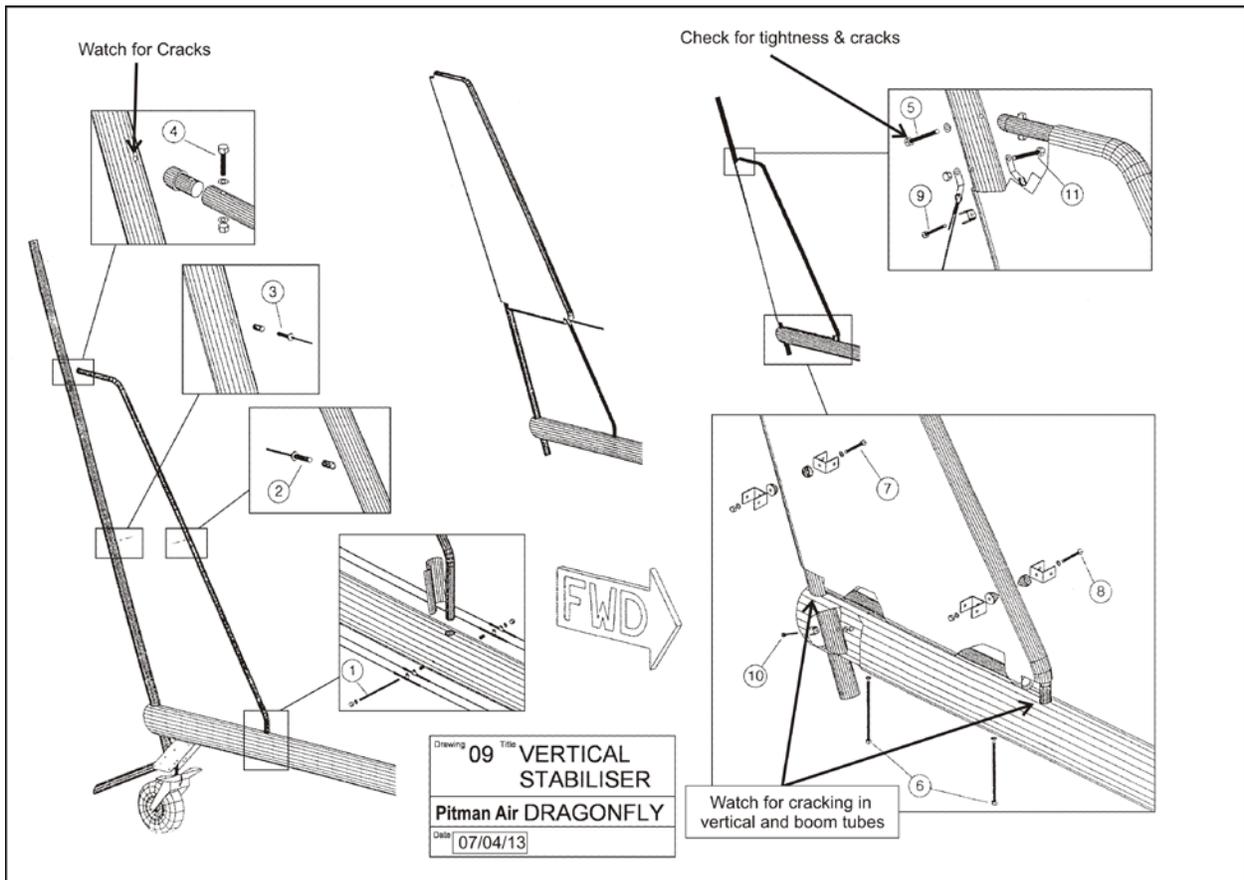
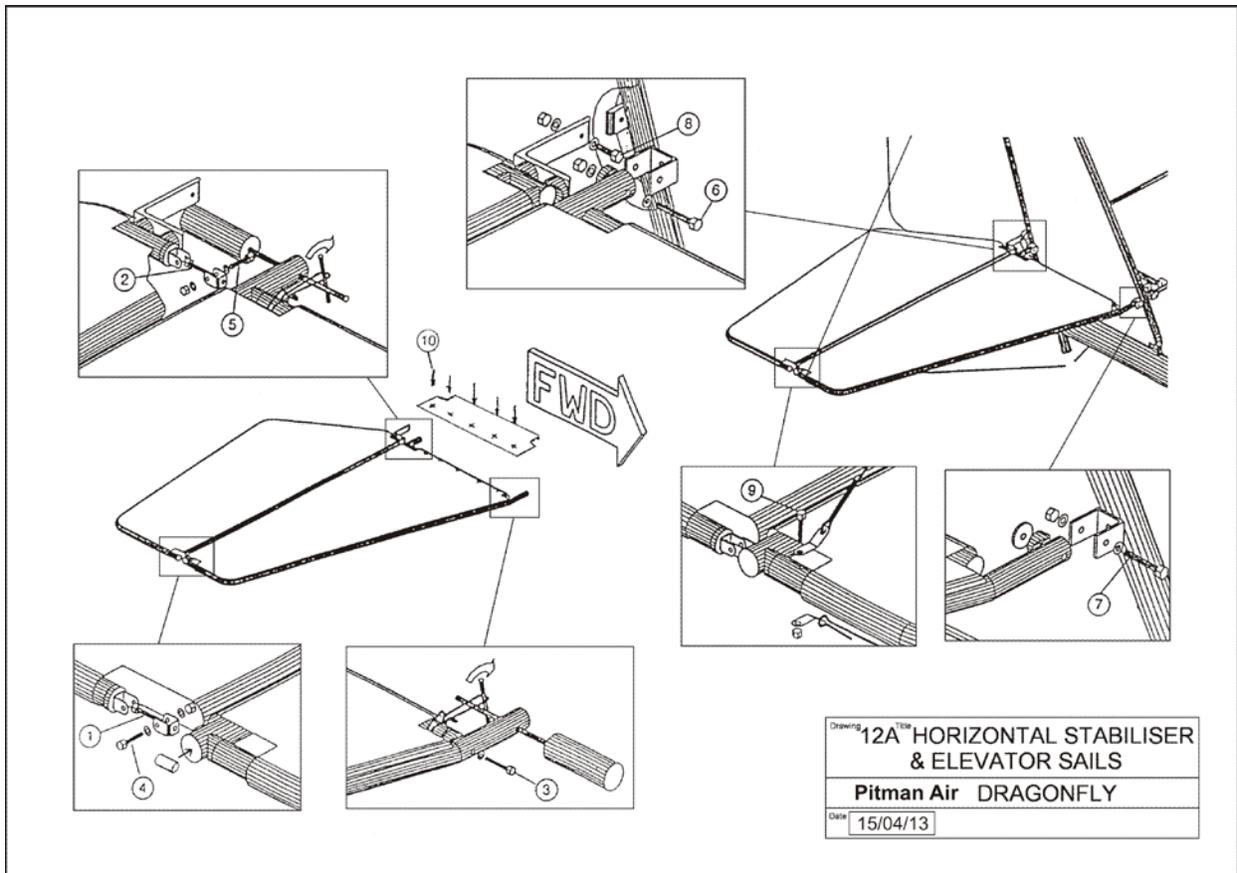
The process replace bolt that passes through Vertical Stabilizer Leading Edge Tube and Horizontal Stabilizer Leading Edge Attachment Brackets. (2 each, **horiz stab brkt DFI 008 Section 9 # 7 & 8**). This bolt can be identified by referring to the Dragonfly Maintenance Manual Section 9 Step 8. Also refer to Sections 8 and 12 during instructions.

Second loosen bolt and nuts (But to not remove nut) holding cables between tail wheel bracket, outboard of horizontal stabilizers and vertical stabilizer/Tow Mast (seen in Drawing 12A) This will allow slack in the cables to do your work. Disconnect lower part of lower cables at Tail Wheel bracket Item 13 in Section 8. and Bolt 8 in Drawing 12A, allowing horizontal stabilizers to fold up next to Rudder. But leave them down for now. On the side of the Bolt Head (the bolt we are replacing, Bolt 8 Section 9) remove Bolt 7 Drawing 12A to allow the leading edge to be lifted out of the way, to allow clearance to pull the bolt we are replacing. Tighten nut Tight but do not crush tubing of Vertical Stabilizer. Put Leading Edge of Horizontal Stabilizer back in position and replace Bolt 7 Drawing 12A.

Now confirm Horizontal Stabilizers can be folded up without hitting the new Bolt or Nut. **Be sure Bolt 8 of Drawing 12A is removed**, This bolt ties the action of both elevators together. If needed a little of the Leading Edge Tube of the Vertical Stabilizer can be removed with Die Grinder or Rattail File. Only remove enough to gain clearance.

Inspect Reassembled brackets with **Certified AN3-25AS and Metal Nut AN 363-1032**. Reconnected horizontal stabilizer leading edge with hardware removed. Re attach cables to tail wheel bracket and **replace Bolt 8 in Drawing 12A** which forces stabilizers to work together. Tighten bolts as described in each section concerned. Insure all Fasteners are properly installed and tightened to specified values in manual.
